Others

<i>Contents</i>	<i>Page</i>
Others	
Re-tightening of Bolts	710.02
Exhaust Valve, Spare Parts	710.03
Fuel Valve, Atomization Test	710.07
Maintenance of Starting Air Distributor, S46/50MC-C	710.12
Service Letter, Ignition in Crankcase	710.13
Service Letter, Burnt Exhaust Valve Seats	710.14

No: SL97-352/KMJ
November 1997

K/L/S-MC Engines
Burnt Exhaust Valve Seats
Lifting/Rotation Indicator

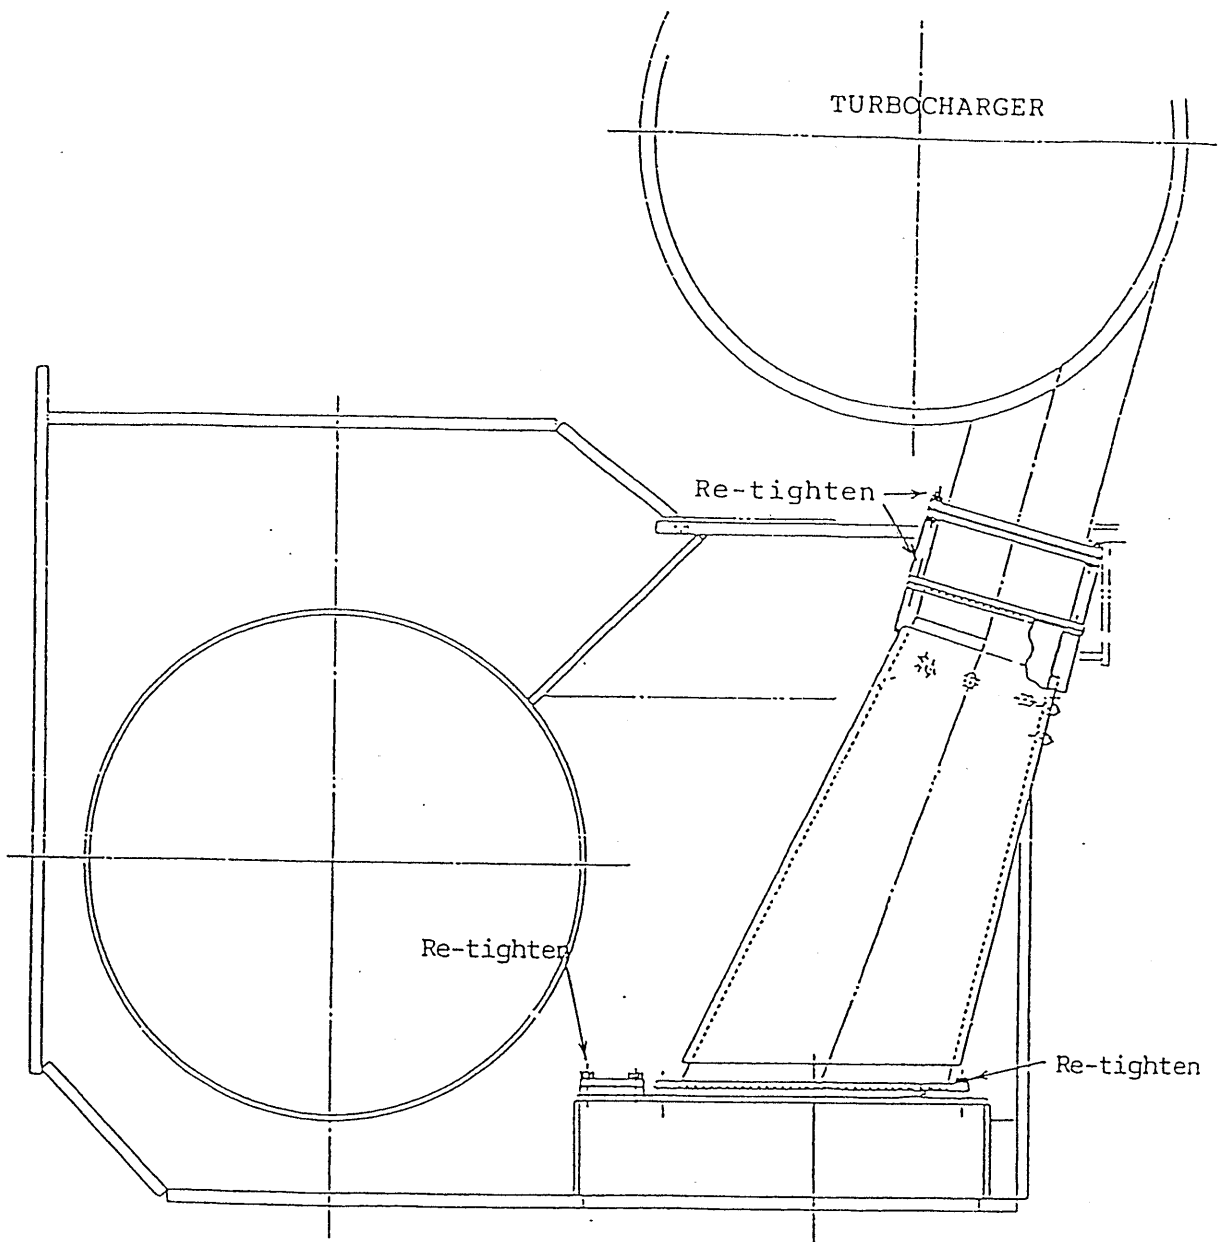
In order to prevent air leakage from the joint in the turbocharger delivery pipe, it is requested to re-tighten the bolts shown in the sketch below after about one month in the maiden voyage.

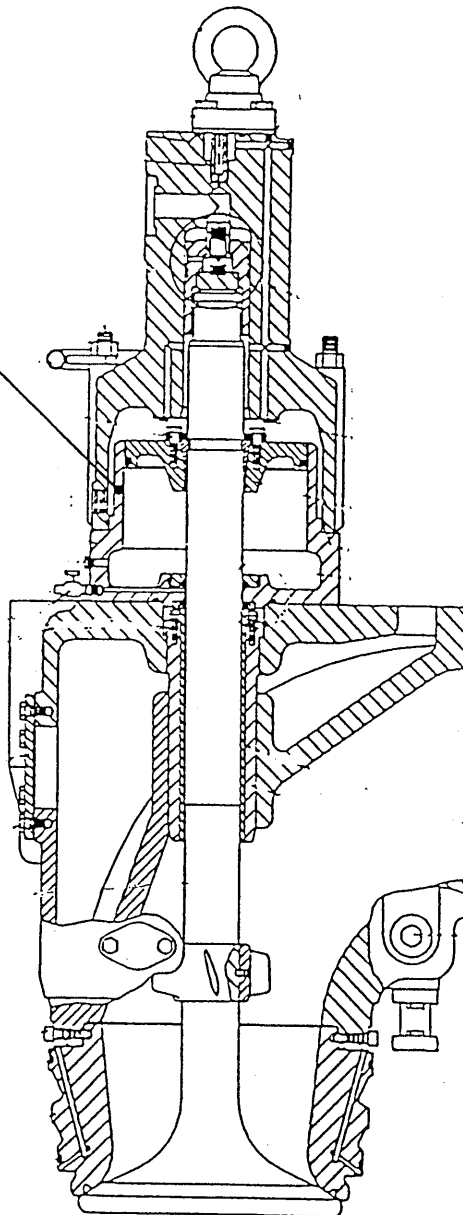
Air cylinder

When spare exhaust valve is first put on the engine for overhauling of the working one, please confirm that there is no rust taking place on the inner surface of the air cylinder.

The surface might be rusted during the storage.

Please carry out checking of the preservation of spare exhaust valves every 4000 hours.

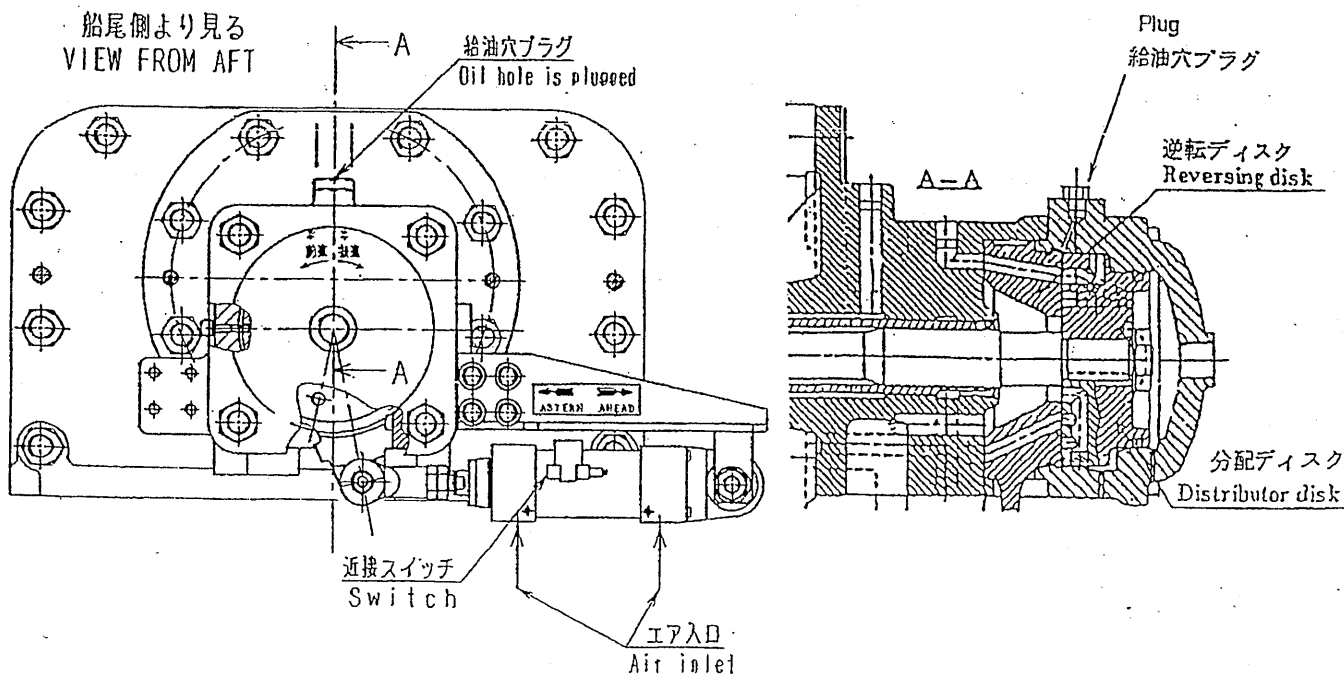
Maintenance of starting air distributor (disk type), S46/50MC-C

Two end switches with a roller arm are used for detecting completion of the reversing disk change-over. Be careful about correct positioning of the end switches, because the main engine will not be started if the roller arm of the switch is not correctly pressed. Even in such a condition the engine starting is possible at the local control stand.

Remove a plug located at the top of the cover and supply clean LO until it overflows from the plug hole. Oiling to be done once in 1-2 months while the main engine is running. Be careful not to allow foreign particles to sneak into the distributor.
